TECH TIPS

FROM NASSCO

MANHOLE REHABILITATION: IS CORROSION REALLY CAUSED BY H₂S?

By NASSCO member Craig Gaul, President, Parson Environmental Products, Inc.

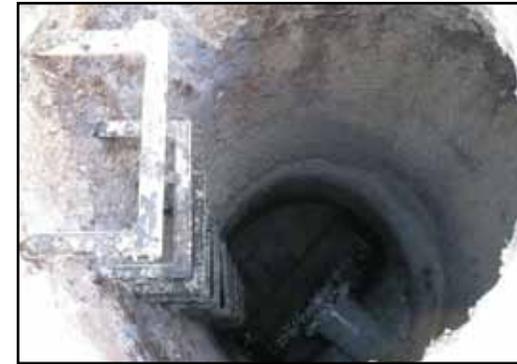
SEVERELY DETERIORATED, SEVEN YEAR OLD PUMP STATION DISCHARGE MANHOLE IN CENTRAL OHIO.

Our industry often (incorrectly) refers to the deterioration of sewer pipe, manholes and lift stations as "a gas problem" when the real culprit of concrete deterioration is microbial-induced corrosion, or MIC. It is a process whereby anaerobic (non-air, or oxygen breathing) bacteria common to municipal waste flows form in raw sewage effluent and naturally create hydrogen sulfide gas (H₂S). Initial factors contributing to rapid bacterial growth are temperature, retention time, and high biochemical oxygen demand (BOD) levels. These factors are common in force mains, but can also occur in large flat pipes with little aeration of the sewage. The H₂S gas is then metabolized by aerobic bacteria which create large quantities of sulfuric acid.

As soon as the pH of the concrete falls from its initial levels of 11-12 to around 9, biological colonization of aerobic (air breathing) Thiobacillus bacteria will begin. The countdown to serious corrosion and collapse begins at this point since bacteria have the unique ability to convert hydrogen sulfide gas into sulfuric acid (H₂SO₄) in the presence of oxygen.

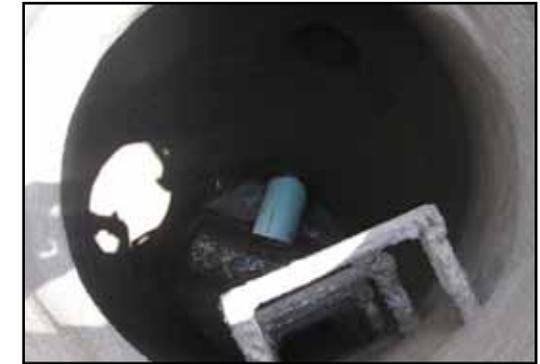
SAME MANHOLE AFTER REHAB WITH 1.5" THICK CEMENTITIOUS LINER WITH ANTIBACTERIAL ADDITIVE.

There are a few antibacterial admixtures available on the market that are added to the mix water of a cementitious manhole rehabilitation mortar. This combination not only rehabilitates the deteriorated structure, but also creates an unfriendly and uninhabitable environment for Thiobacillus bacteria growth, which will eliminate the formation of sulfuric acid, that we now know to be the real culprit in wastewater collection system deterioration.

These products are water soluble, cannot wash off, deteriorate, lose their effectiveness from wear and are safe for human and animal contact. Abrasion or erosion of the concrete surface only serves to expose additional material to the surface, which would otherwise foster bacterial growth. The end result is structural integrity has been restored to the deteriorated structure and its life will be extended well into the future.
